20. ABSTRACT (Continue on reverse side if necessary and identify by block number) Mary's Creek Watershed Dam No. 8 is a curvilinear earthen structure 1120 feet long and 30.0 feet high with a crest width of 12 feet. The upstream and downstream slopes are 1V:2.4H and 1V:3.5H respectively. At normal pool, the 25 acre lake has a storage capacity of 149 acre-feet. At the top of the dam the pool area increases to 45 acres with an impoundage of 380 acre-feet. The drainage area for the lake is 286 acres. It is predominantly pasture and woodland with an average ground slope of approximately 5.6%. The dam is uniform, well grassed, and clear of any deleterious vegetation. The upstream

Based upon the inspection and subsequent evaluation, Marys Creek Watershed No. 8 is classified as deficient due to insufficient storage and spillway capacity to pass the one-half probable maximum flood and minor erosion of the dam.

MARY'S CREEK WATERSHED DAM NO. 8
SHELBY COUNTY
MARCH 27, 1981

PHASE I INSPECTION REPORT
NATIONAL DAM SAFETY PROGRAM
TENNESSEE

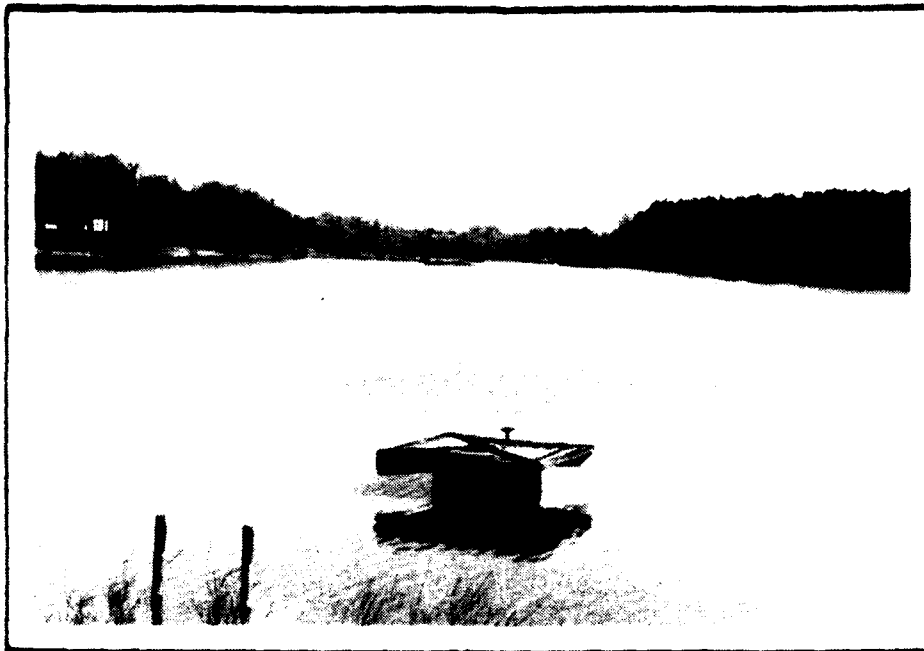
PHOTO NO. 7

- 3.1.2 Service Spillway and Drawdown - The spillway riser appears to be in good condition as viewed from the dam. There appears to be no broken or lost timbers from the anti-vortex baffle or floor cap (see photo no. 7). The spillway outlet is submerged in the plunge pool and was inaccessible for inspection (see photo nos. 13 and 14).
